Name of Dam: Camp Shenandoah Dam.
Location: Augusta County, State of Virginia
Inventory Number: VA 01515

PHASE I INSPECTION REPORT
NATIONAL DAM SAFETY PROGRAM.

Camp Shenandoah Dam (VA 01515).
Potomac River Basin. Augusta County,
State of Virginia. Phase I Inspection
Report.

SEPTEMBER 1978

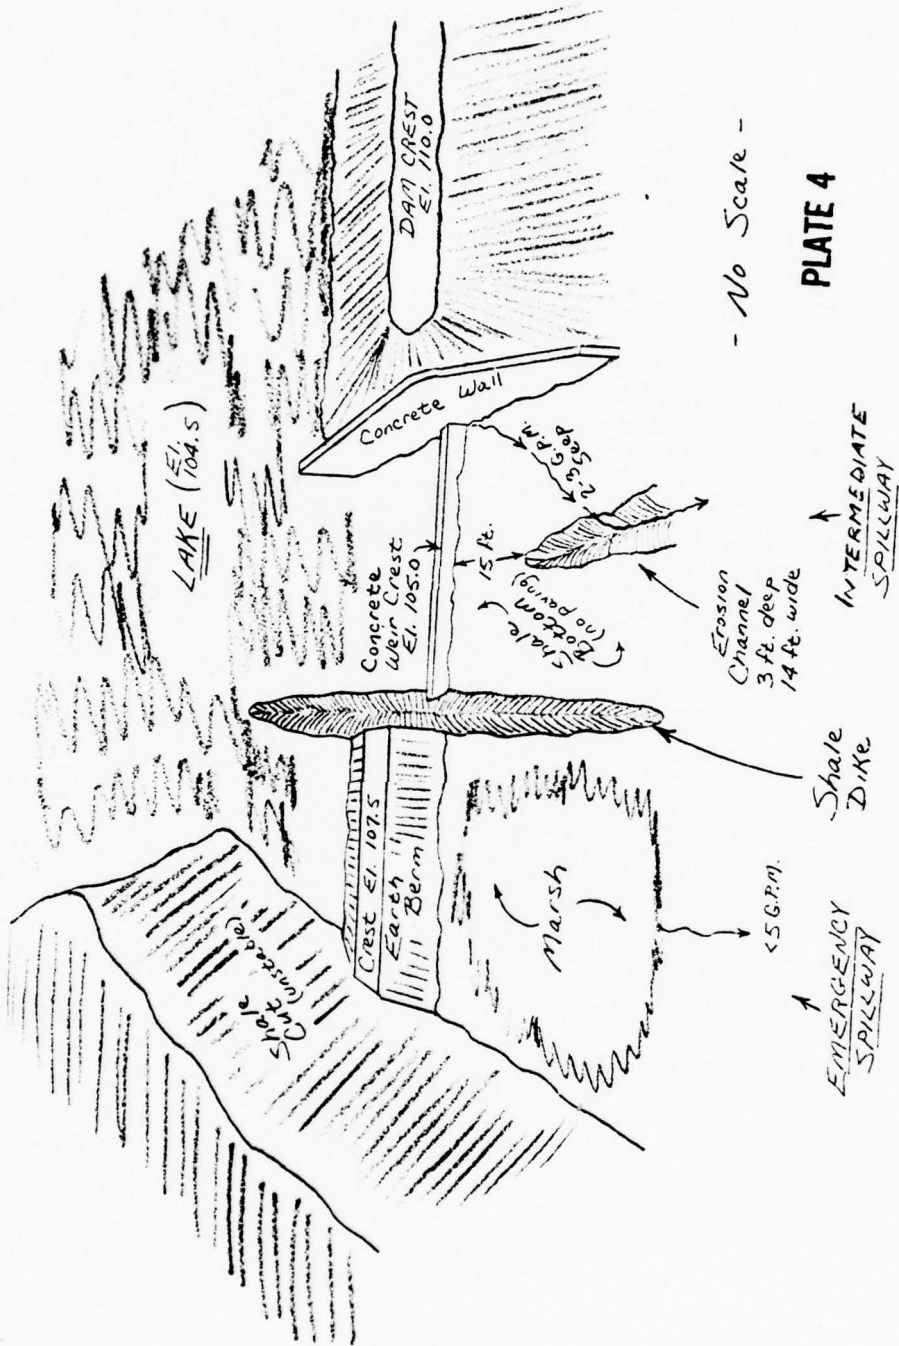
- CAMP SHENANDOAH DAM, VIRGINIA -
SKETCH OF EXISTING SIDE CHANNEL SPILLWAYS

A plan view of the dam and typical sections are included in this report as Plates 1, 2 and 3, respectively. The spillways are not constructed as planned. Plate 4 is a sketch of the actual spillway features.

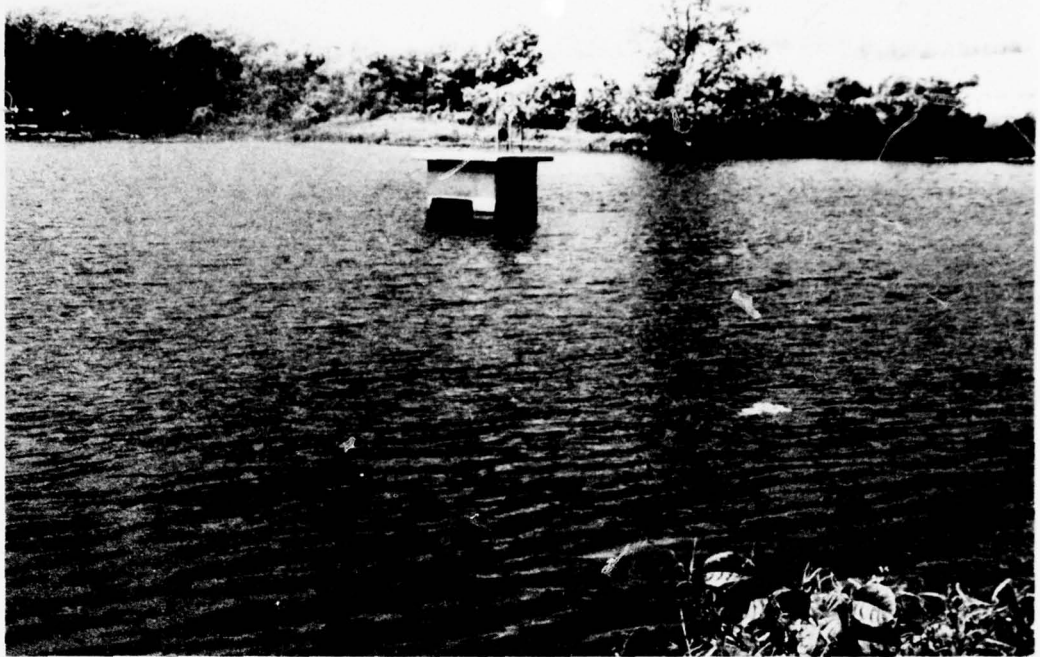
- 3.1.3 Appurtenant Structures: The inlet structure, outlet pipe and emergency gate are generally in good condition. However, the mesh of the trash rack (see Photo 1) on the intake tower is small (three-fourths of an inch) and could easily clog. The ladder for access to the tower is rusted through in a few places.

PHOTO 1. Overflow Intake Tower

VISUAL EXAMINATION OF	OBSERVATIONS	REMARKS OR RECOMMENDATIONS
CRACKING AND SPALLING OF CONCRETE SURFACES IN OUTLET CONDUIT	Concrete appears to be sound.	
INTAKE STRUCTURE H H H - 4	Concrete is apparently in good condition, but the small mesh (three-fourths of an inch) of the trash rack could be easily clogged.	Replace the old trash rack with a trash rack with larger mesh openings.
OUTLET STRUCTURE	Outlet is 24 inch inner diameter concrete pipe. Concrete apron around outlet may have been present at one time but is broken.	Possibly, riprap should be placed around the outlet.
OUTLET CHANNEL	Heavily overgrown meandering channel. The channel is not riprapped.	The outlet channel should be kept clear of brush. Riprap may be desirable along outlet channel.
EMERGENCY GATE	There is a 20 inch sluice gate which is operated by a hand crank. It appears to be in operating order; last used by camp personnel in 1977. The sluice gate's bottom elevation is 80.0 feet (assumed datum). The gate will drain the lake.	Periodically test the emergency gate to insure that it is in operating order.

- 8) Riprap around the outlet conduit and immediate discharge channel.
- 9) Replace the intake tower trash rack (three-fourths of an inch mesh) with larger mesh or a bar screen. Repair or replace the intake tower access ladder.

- 1) Place riprap around the principal spillway outlet and its immediate discharge channel.
- 2) Replace the intake tower trash rack with larger mesh screening or a bar screen.
- 3) Repair or replace the intake tower access ladder.

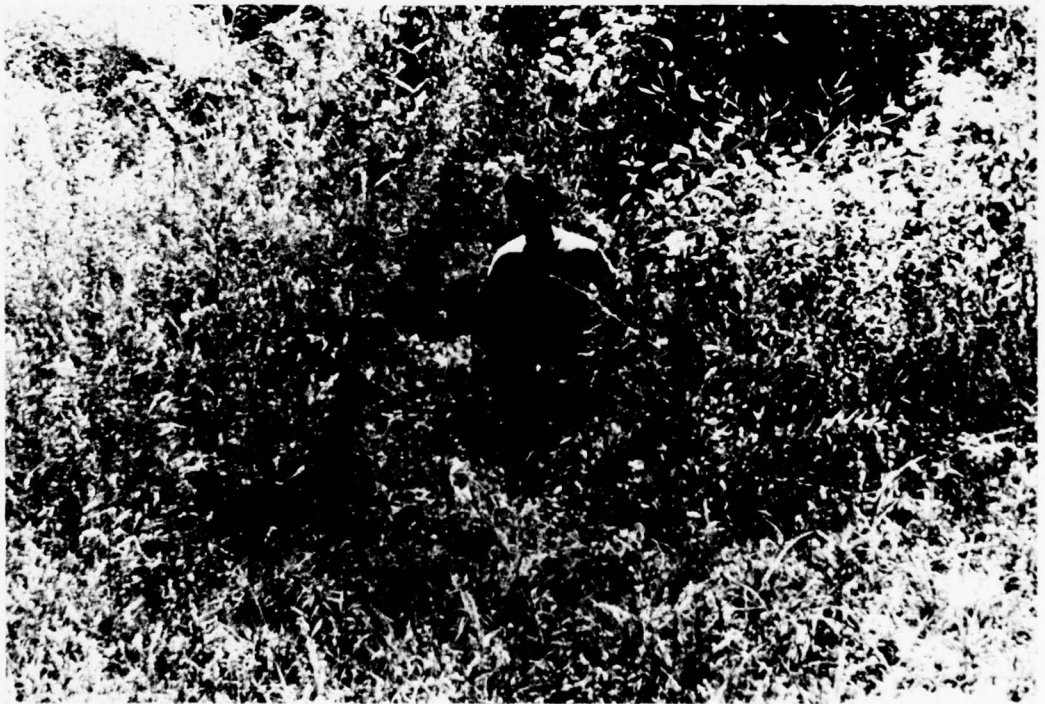
extending to the outlet discharge channel (see Photo 2). Water from the impoundment will enter this ditch from the culvert at elevation 106.9 (assumed datum). The ditch and culvert, at present, act as a crude secondary emergency spillway. Flows in the ditch have significantly damaged one-half of the downstream toe of the dam.

PHOTO 2. Eroded Ditch Along Northern Toe of Dam

- 4) Backfill the drainage ditch along the northern shoreline and remove the corrugated metal pipe which extends through the north abutment. Repair and reseed the area that has been eroded along the northern downstream toe of the dam.

abutment, and repair the erosion that has occurred along the northern toe of the dam.

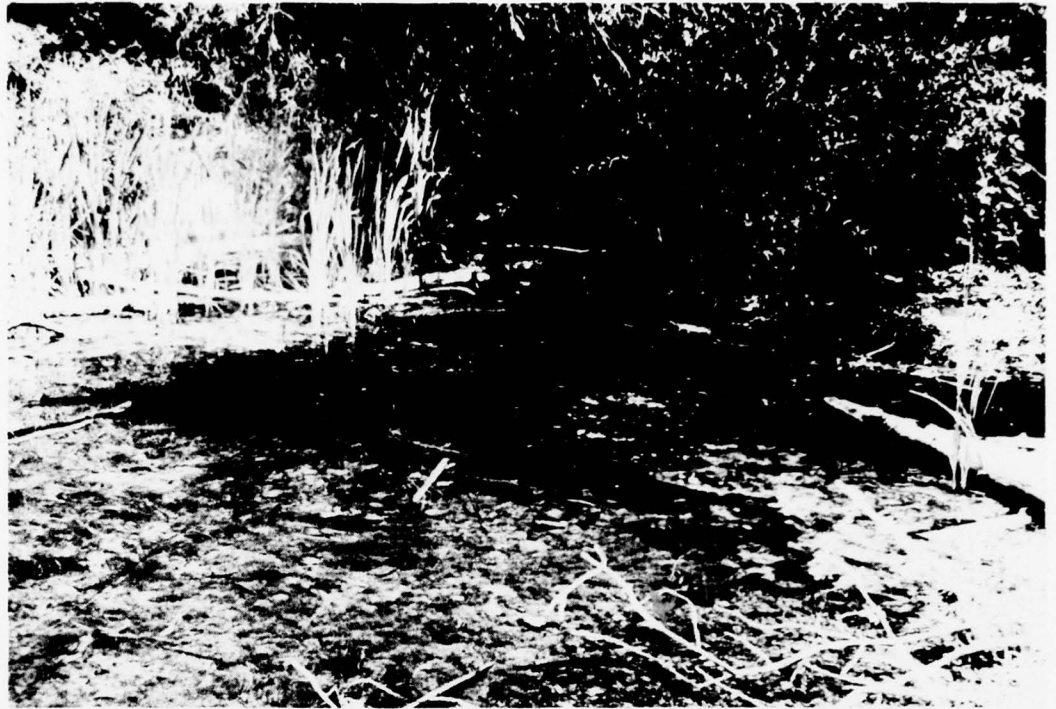
PHOTO 3. Intermediate Spillway Approach End

APPROACH CHANNEL		The approach channel is heavily overgrown with brush and trees. Debris up to six inches in diameter was found (in both the intermediate spillway and emergency spillway).	Clear the approach channel of all growth, except grasses.
------------------	--	---	---

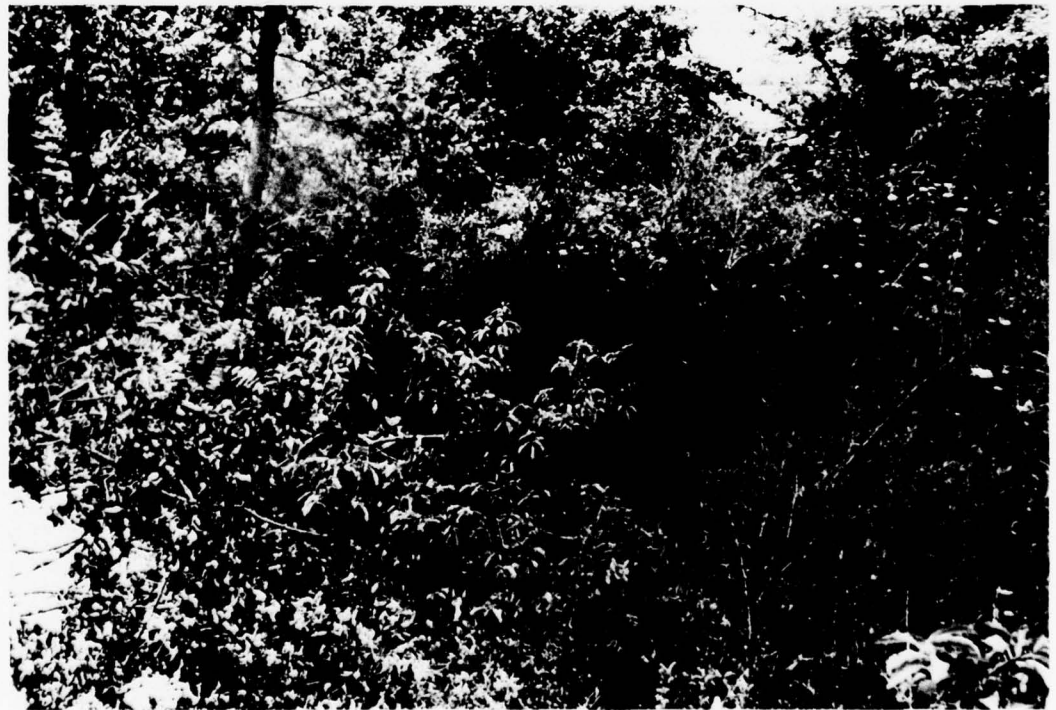
PHOTO 4. Emergency Spillway Approach End
(Intermediate Spillway and Emergency Spillway Are Two Distinct, Adjacent Channels.)

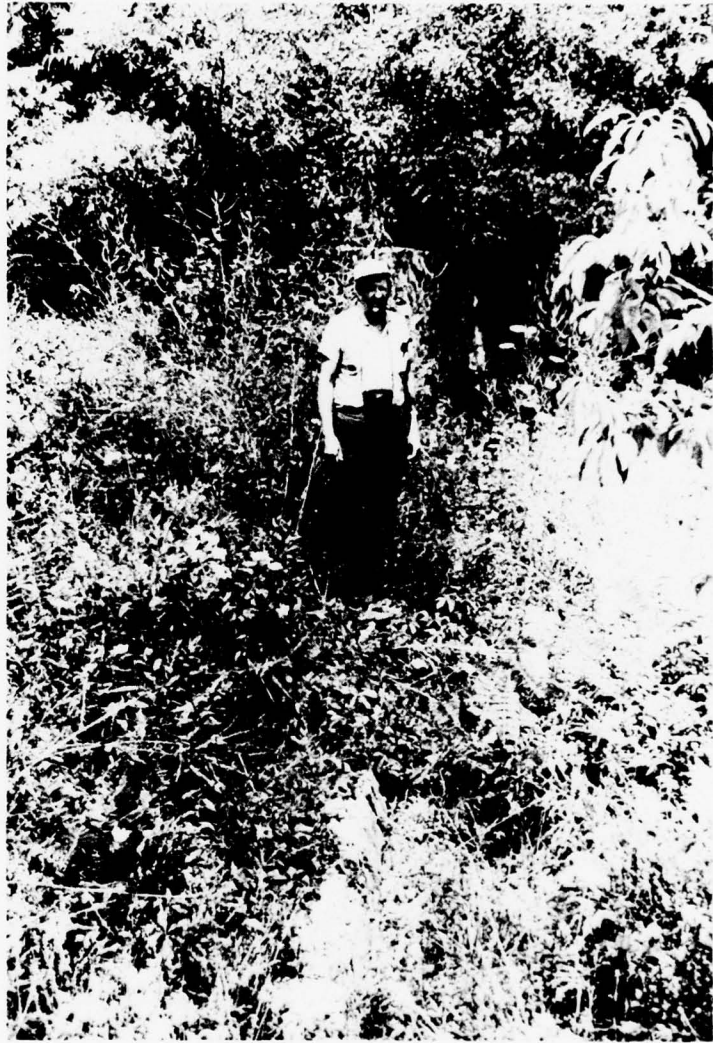
PHOTO 5. Concrete Weir in Intermediate Spillway

VISUAL EXAMINATION OF		OBSERVATIONS	REMARKS OR RECOMMENDATIONS
CONCRETE WEIR (INTERMEDIATE SPILLWAY)		Slightly eroded, but no structural defects were observed. No flow over weir at time of inspection (crest elevation 105.0 [assumed datum]). An approximate three to five g.p.m. seep is occurring under the north end of the weir. This seep probably occurs through joints in the shale bedrock observed to be originated about in line with the longitudinal axis of the spillway.	Monitor seep under weir to determine if undercutting could occur.

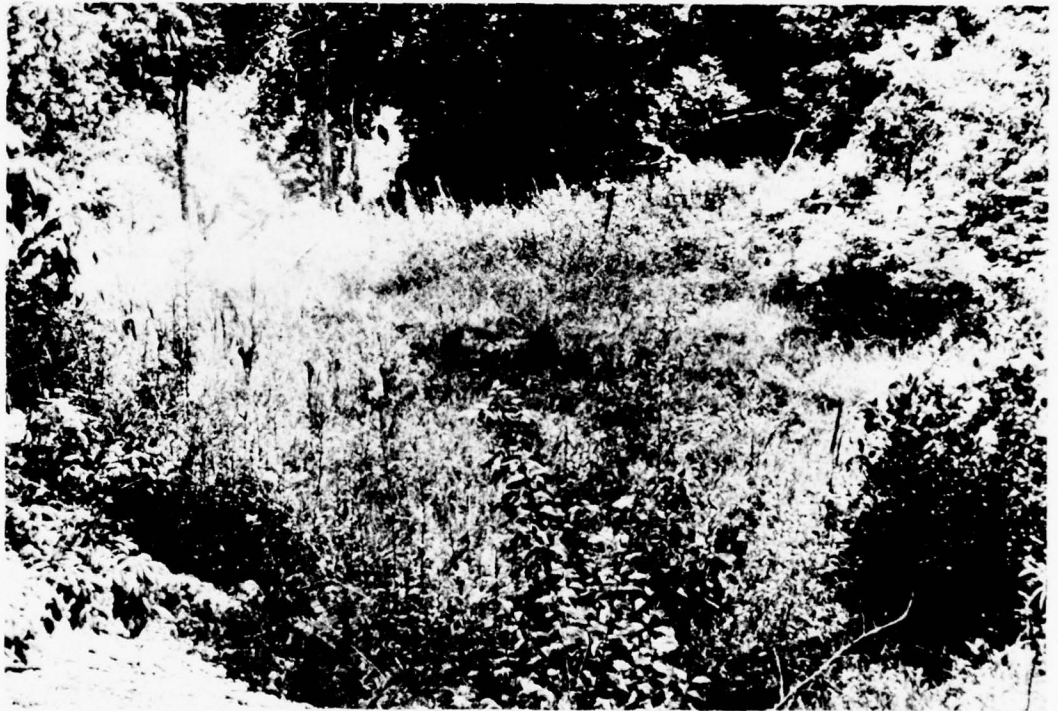
A heavily tree covered berm constructed of clayey fill acts as the crest of the emergency spillway. The crest is at elevation 107.5 (assumed datum) (2.5 feet above the crest of the intermediate spillway). The design width across the crest of the berm was eight feet; actual width is a maximum of four to five feet. The width at the base is approximately 20 feet. A clear seep of less than five g.p.m., in the form of a marshy area, was observed in the discharge channel of the emergency spillway just below the berm (see Photo 6). Seepage may flow through the berm or through joints in the underlying shale.

PHOTO 6. Clear Seepage in Emergency Spillway Discharge Channel

VISUAL EXAMINATION OF		OBSERVATIONS	REMARKS OR RECOMMENDATIONS
DISCHARGE CHANNEL (continued)	3)	The earth berm across the emergency spillway is only four to five feet, maximum, in width at its crest. The design width is eight feet. The existing berm could be eroded easily if the berm is overtopped. The crest of the berm is at elevation 107.5 (assumed datum).	3) Widen the berm and riprap it for protection.
	4)	A small (less than five g.p.m.) seep is occurring through or beneath the berm of the emergency spillway area in the discharge channel.	4) To maintain the berm, a clay liner berm may be desirable to prevent piping under high water conditions.
